## RESTORATION STRATEGIES FOR A COMMERCIAL FACILITY: FACADE OF CENTRUM-RENOMA DEPARTMENT STORE IN WROCLAW

### Abstract

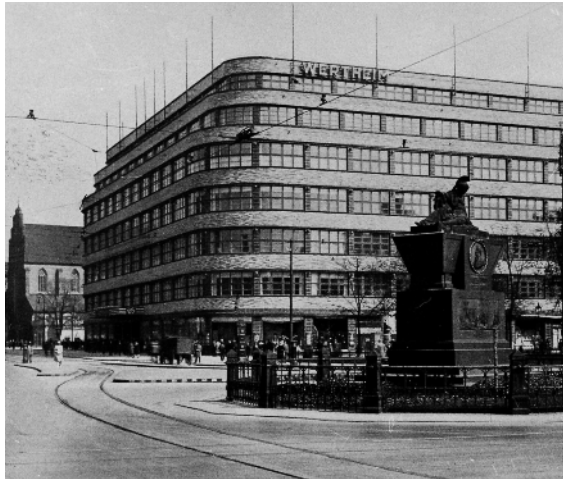
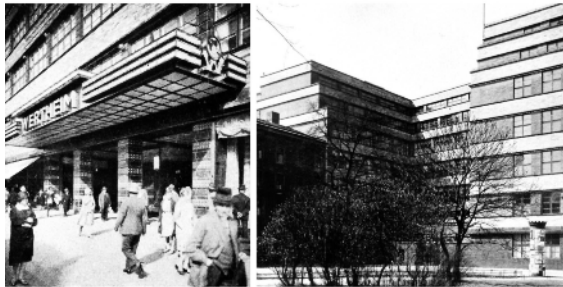
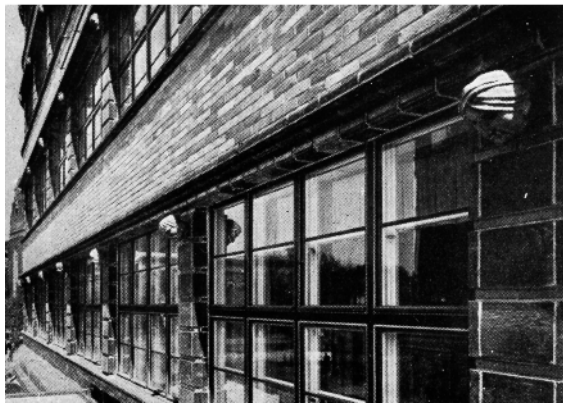
**Figure 1.** Warenhaus Wertheim soon after the launch in 1930. Top: southern view of the building with Gen. F.B. von Tauentzien's monument in the foreground. Middle left: main entrance from Świdnicka street. Middle right: eastern view of the building. Bottom: part of the western facade with ceramic ornaments and artistic sculptures. All photos from [4]

*Warenhaus Wertheim* in Wrocław was erected in 1930, following the design delivered by a highly regarded architect – *Hermann Dernburg* for *WERTHEIM Grundstücks Gesellschaft m.b.H. Berlin Technisches Büro* [1]. When built, it was the largest department store in the East of Berlin. Modern, in terms of spatial arrangement and structure, the facility offered the state-of-the-art furnishings. The structure itself, assuming perfectly organised large sales departments surrounding four floor high glass finished courtyards, took after the commercial and architectural experience of *Georg Wertheim* – the chain owner [2]. He was known for employing some prominent architects to design his stores; among them, *Alfred Messel* – the author of *Wertheim* department store in *Leipzigerstrasse*, Berlin [3], or *Hermann Dernburg* – professor of Berlin *Kunstakademie*. The spatial concept developed for Wrocław branch of the company, based upon the modernist idea where the commercial function of the building was reflected by its structure and shape to perform as a giant commercial sign [4]. The basic structure of the building was a steel skeleton, supplied by *Carlshütte* of *Wałbrzych*, to which a ceramic face was attached. Three major facades with the levelled attic and the horizontal composition gen-

erated by alternating belts of the separated windows and parapet walls, were made more dynamic by curved corners and offset terraces on the fifth and sixth floor. The ground floor, separated by a cordon cornice of clinker and brass, was dominated by glazing shop windows in frames of gold plated brass. The main entrance, situated centrally, from *Świdnicka Street* was moved back and covered by the bracketed umbrella roof. Four posts of the entrance were emphasised by glass mosaic and rows of gold plated vee blocks. The floors one through four which were the main body of the facade included alternate belts of walls faced with fine clinker profiles (from the top and bottom lined with heavy ceramic cornice) surrounding the whole building as well as lines of windows separated by pilaster strips. The strips were faced with large size ceramic tiles the texture of which (wide dark tiles and narrow gold plated ones) produced the rustication effect. Ceramic sculptures showing human heads or flower finials were placed at the top of each pilaster. Terraces were designed within the steplike retreating floors five and six; these were restricted by attic walls tiled with bright shapes and covered with massive ceramic caps. These were integrated with steel balustrade set deeply in the walls, so that the fixing elements performed in fact as structural reinforcement linked with the headers. On the top attic level there where 24 metal flagpoles – a very popular means of advertisement then.

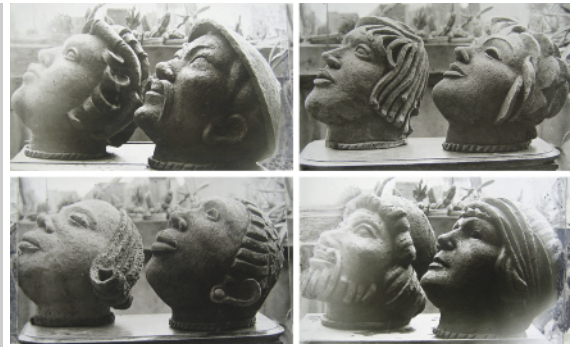
**Figure 2.** Ceramic heads at raw state (before burning) made in 1929 by Ulrich Nitschke in his Berlin studio. The head in the bottom right picture shows the artist's wife – Hadwig. That was the only portrait, the model for which could be established. Owned by Yvonne Bannek

As proved by the information as well as archive records obtained from the sculptors' descendants: *Ulrich Nitschke's* granddaughter – *Yvonne Bannek* [9] and *Hans Klakow's* son – *Ditrich Klakow* [10] both artists worked independently of each other (their diaries contain no entries about any cooperation whatsoever). In 1929 *Ulrich Nitschke* won *Herman Dernburg's* order to supply 25 heads. Each of them was supposed to be delivered in four copies. Today only one of the sculptures has been proved to appear in four copies. It shows the head of *Hadwig* – *Ulrich Nitschke's* wife (there are actually three items on the facade while existence of the fourth is proved by a historical photograph. It has been established that the artist prepared his prototypes “on the spot” while their replicas were made through copying (squeezing) in moulds. It may be suspected that some moulds were used to produce several types of heads, differences introduced at the final stage by differentiating hairstyle or providing empty eye sockets. The inventory made in 2007 pointed however to 32 models of heads present, showing clearly some distinctive ethnic features: European, Negroid, East-Asian or Semitic [11]. The archive pictures taken in the studio of *Ulrich Nitschke* in 1929 revealed also a few models which are presently not found on the facade. Supposedly, it was the tremendous speed of the works or the charm of the sculptures that contributed to increasing their number.

The scope of works commissioned to *Nitschke* and no documentation relating to finials or cones found in his archives suggest that they had been made by *Klakow*. Altogether there were 14 models which were repeated four times. Today, on the facade we can recognise four repetitions of three types of finials. The methods of the artist's work and the level of complexity were similar to those for the heads, how-

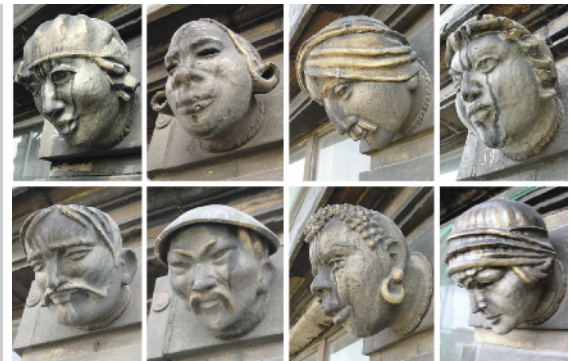
**Figure 3.** Some chosen ceramic heads preserved in the facade of Centrum – Renoma shopping centre – formerly Wertheim department store. The bottom right sculpture shows Hadwig Nitschke. As in 2007 – before renovation. Photo by R. Pabiańczyk

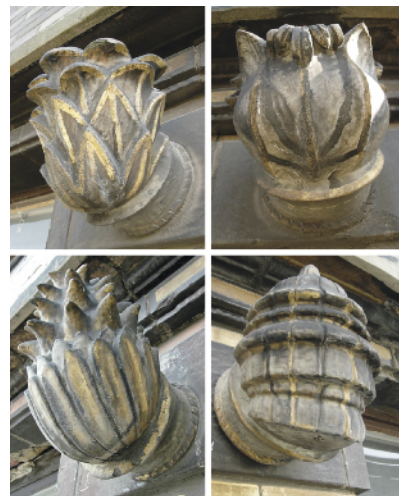
**Figure 4.** Some ceramic flower finials by Hans Klakow preserved in the facade of the department store. As in 2007 – before renovation. Photo by R. Pabiańczyk

ever one mould could only be used for a single type of a finial.

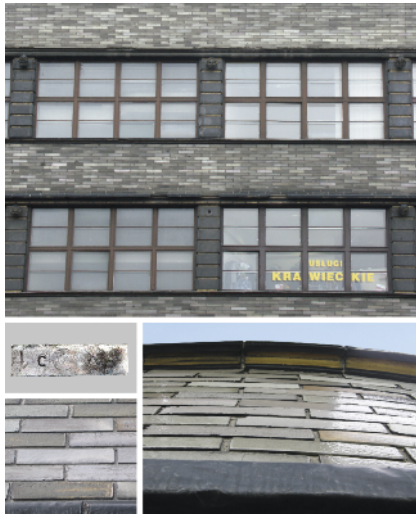
**Figure 5.** 2006 condition of facade designed in 1930 by Herman Dernburg. Top: relatively well preserved central part of the northern facade. Middle: ceramic tile showing the mark of Richard Blumenfeld Velten AG brickyard. Bottom right: attic wall at the rounded corner from Świdnicka street side; the sill tiles were bent before burning. Bottom left: fragment of flat wall faced with small size tiles, some of which were gold plated. Photo by P. Kirschke, 2006-2007

Throughout the 50 years to come, when the building served as the *Powszechny Dom Towarowy* [*Popular Department Store*] and since mid seventies of the 20<sup>th</sup> century as the department store *Centrum-Renoma*, the original face was gradually deteriorating. Penetrating through fractures in the clinker glaze, water reached the wall structure sometimes as deep as the steel framework.

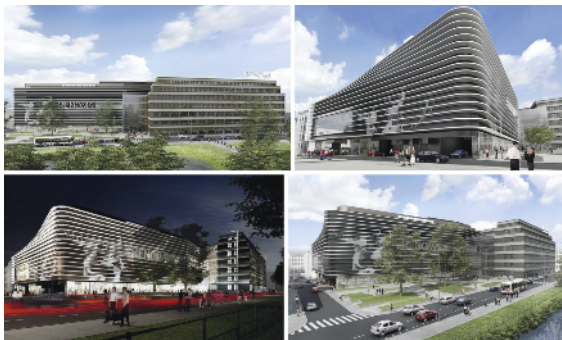
**Figure 7.** Renovation, reconstruction and expansion concept for Centrum-Renoma department store. Northern and eastern view at the old and new part of the facilities. Design by Maćków Design Studio

In 2006 *DTC Real Estate* – the owner of the building, decided to carry out the renovation, reconstruction and expansion of *Renoma* building, according to the commercial conceptual study delivered by *Benoy*, London design office. Reconstruction of this historical edifice was part of an extensive project including construction of a new eastern wing to accommodate shops and services as well as a multi-storey parking lot serving the whole estate. Development of the building project was commissioned to Wrocław design office *Maćków Pracownia Projektowa*, [16]. Renovation of the substantially weakened structure of the department store and erection of the new wing as well as designs of the installations were entrusted to *ARUP*, Warsaw. It has been assumed that the building will serve commercial purposes, with 17000 m<sup>2</sup> usable area on floors one through three and offices taking 10000 m<sup>2</sup> on floors 4 through 6; all technical functions shall be accommodated in the new wing [17]. The chief designer is *Zbigniew Maćków* and the team of architects includes *Krystyna* and *Paweł Kirschke*. Taking advantage of the knowledge gained during the case study performed as well as some earlier reconstruction and renovation projects, the architects have proposed the restoration strategy which assumed preservation of the historical structure of the building where historical courtyards would perform as nodes of the passage linking the old part of the building with new one, and strong emphasis upon the architectural values, in particular those of the fantastic facade. Such solution was accepted by the Investor and approved of by the Municipal Restoration Office. The programme of facade restoration [18] which took into account war damages, a fire lasting for a couple of days and the wear out of the building, set as priorities the issues of elim-

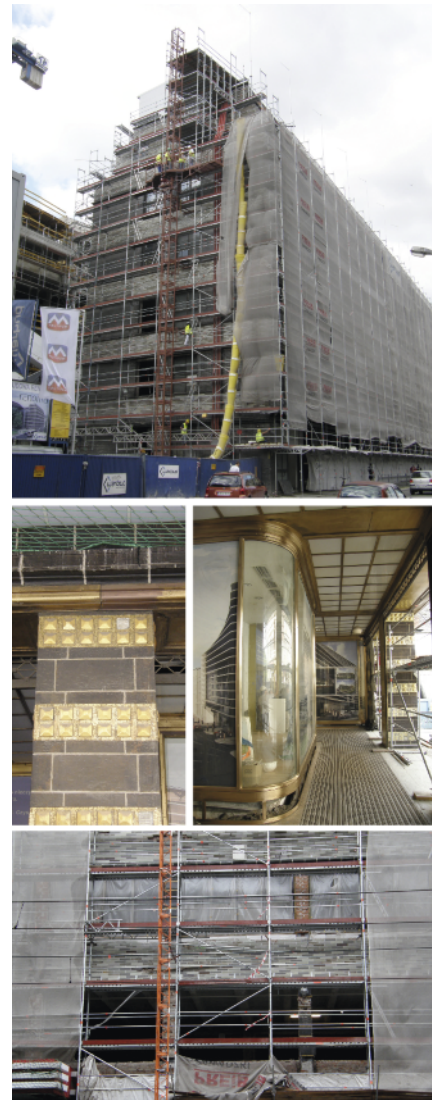
**Figure 9.** Conservation works at the facade of Renoma department store. Top: best preserved eastern part of the building. Middle left: pillar faced with ceramic tiles and gold plated mosaic. Middle right: renovation of brass display windows and of the backlit grate. Bottom: severely damaged western facade with renovated parapet walls. As in 2008. Photo by P. Kirschke

The design assumed that the best preserved eastern facade shall perform as reference to which the texture and colours of all the facility will be adjusted. It has been assumed that renovation of most of the elements of the ceramic face will be carried out on this facade as well as the northern one. Ruined southern and western facades need reconstruction of most of the parapet wall face as well as remarkably damaged profiles forming the window cornice.

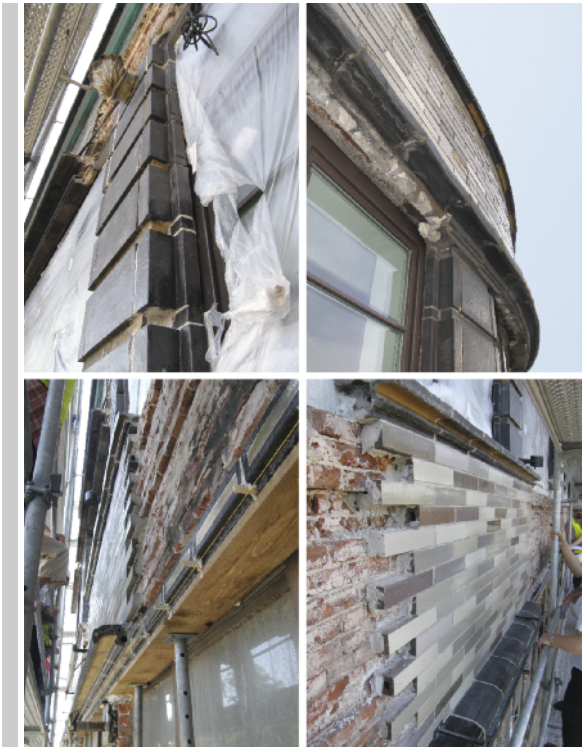
**Figure 10.** Conservation works at the facade of Renoma department store. Top left: fourth floor pillar finished with a flower finial. Top right: attic wall at the corner of the building with corroded sleepers and cornices. Bottom: renovated fragments of the northern facade. As in 2008. Photo by P. Kirschke

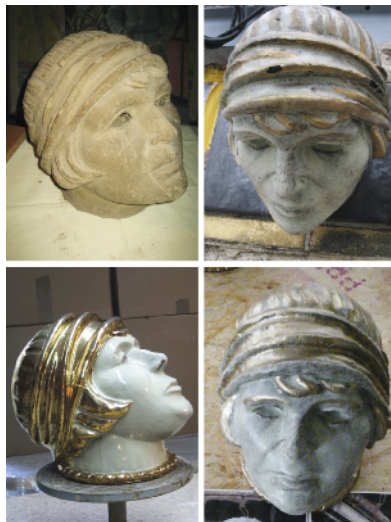
**Figure 11.** Portrait sculptures showing Hadwig Nitschke. Top left: preserved unburnt clay model made by Ulrich Nitschke in 1929. As in 2007. Photo by Y. Banek. Top right: a sculpture undergoing in situ conservation. As in 2008. Photo by M. Gašior. Bottom left: head replica made by Paulina Pokorny-Ziemba. As in 2008. Photo by P. Pokorny-Ziemba. Bottom right: a sculpture removed from the facade to undergo laboratory conservation. As in 2008. Photo by Sz. Kucia

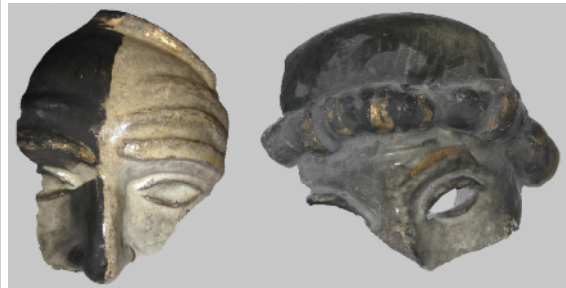
**Figure 12.** Pieces of sculptures falling off the department store throughout the years. Left: first attempt to clean the sculpture which revealed the original colour of the ceramic ornaments. As in 2007. Photo by P. Kirschke

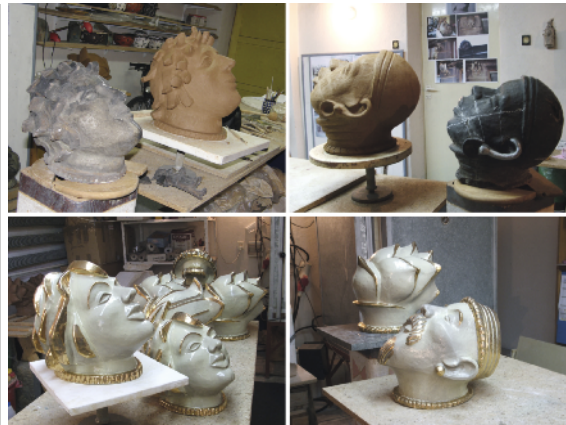
**Figure 13.** Sculpture replicas by Paulina Pokorny-Ziemba. Subsequent stages from the clay models (top left), through the biscuit burnt models (top right) to the multiplied, burnt and gold plated replicas of heads and finials. As in 2008. Photo by P. Pokorny-Ziemba

The results of such raw material and technological research were applied also for reconstruction of the sculptures. As assumed by the design, the facade is supposed to contain 100 heads and 56 finials placed along the historical, axial pattern. In 2007 the facade showed only 86 sculptures, of which only 32 heads and 14 finials were in relatively good condition. A decision whether a sculpture should be renovated in situ or taken off the facade and conserved in the laboratory needed individual considerations, also taking into account the risk of additional damage to a sculpture when removing it. With the use of iconography supplied by courtesy of Ulrich Nitschke's grand-

daughter – *Mrs. Yvonne Bannek* and after analysis of the preserved heads of the facade, it was possible to establish 36 model patterns of those sculptures and 14 models of finials. The missing sculptures are now being reconstructed as replicas of the existing models and multiplied by no more than five times. The replicas are made by the artist, *Paulina Pokorny-Zięba*. The raw materials are clinker clay and glaze, identical to those used for the remaining profiles. After some preliminary tests carried out to develop the manufacturing technology and establish the range of material shrinking after burning, she commenced to create clay models of the heads. Those were used to produce plaster cast which served as moulds to squeeze raw sculptures, multiplied than in 4-5 copies and manually finished by adding details, like for example hair. So far, 72 sculptures have been reconstructed in this way. Burnings were performed: first – a biscuit fire, next – to test the glaze.

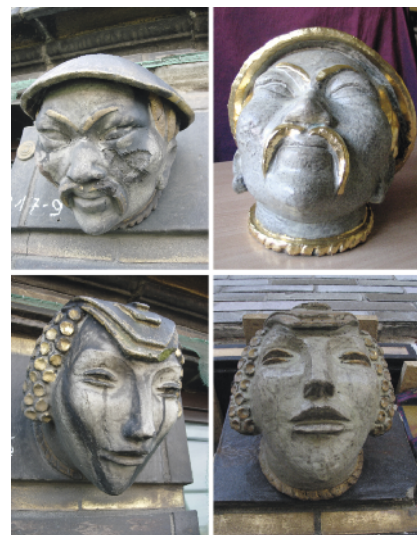
**Figure 14.** Top: "Chinaman" sculpture removed from the facade and renovated in the laboratory. Bottom: in situ renovated sculpture of a woman. Photo by M. Gašior

At the same time conservatory works were carried out in Wrocław and Toruń to restore the historical sculptures taken off the facade. Following renovation, most of them will be exhibited inside the modernised building where one of the walls in the main hall will be adapted especially for this purpose.
